Tornado Intensity Estimation

Tornado Intensity Estimation: A History

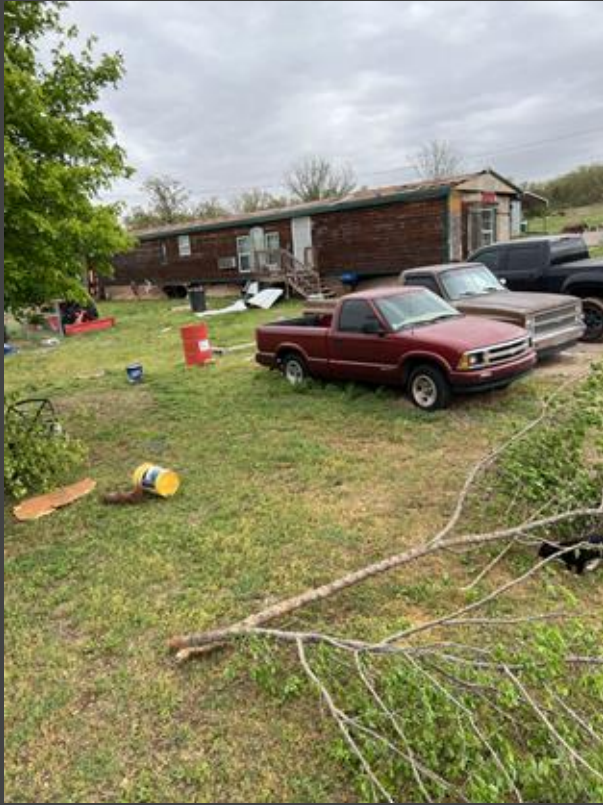
19 Apr 2023 Etowah, OK
DI 3, DOD 2, 75 mph

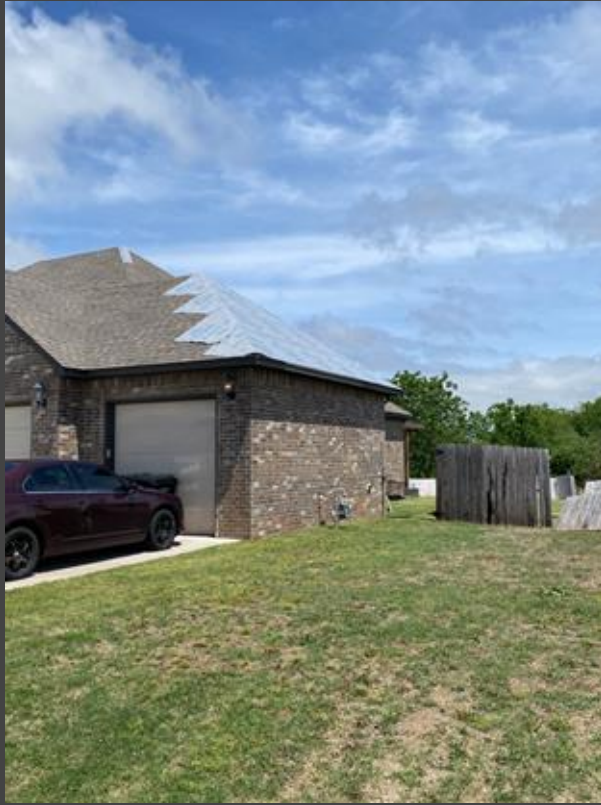
27 Apr 2024 Goldsby, OK
DI 2, DOD 2, 79 mph

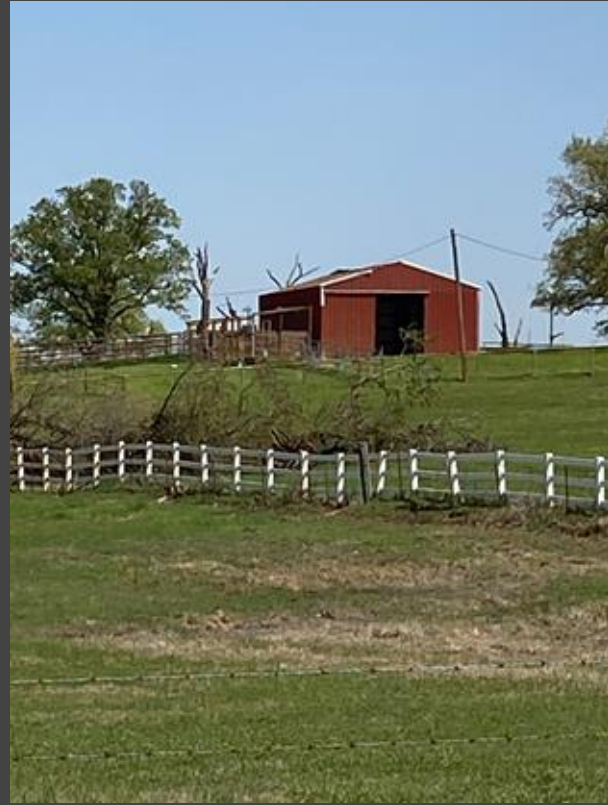
19 Apr 2023 Etowah, OK
DI 1, DOD 1, 65 mph

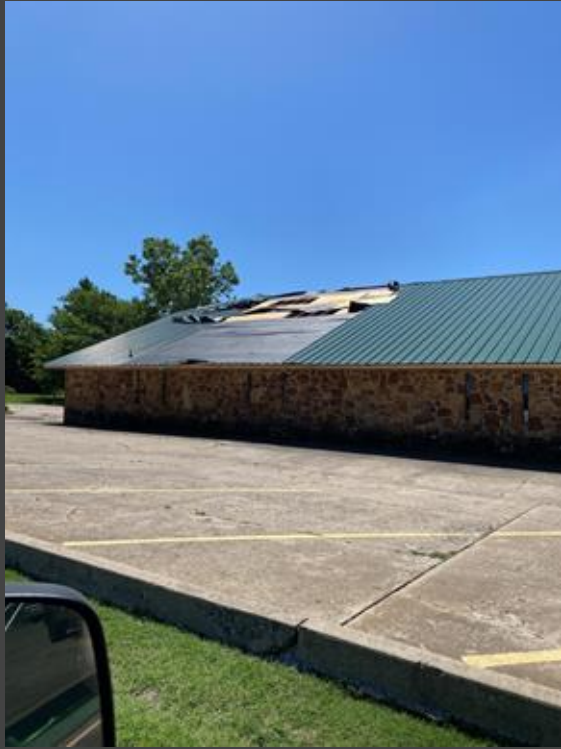
6 May 2024 Oklahoma City, OK
DI 8, DOD 4, 100 mph

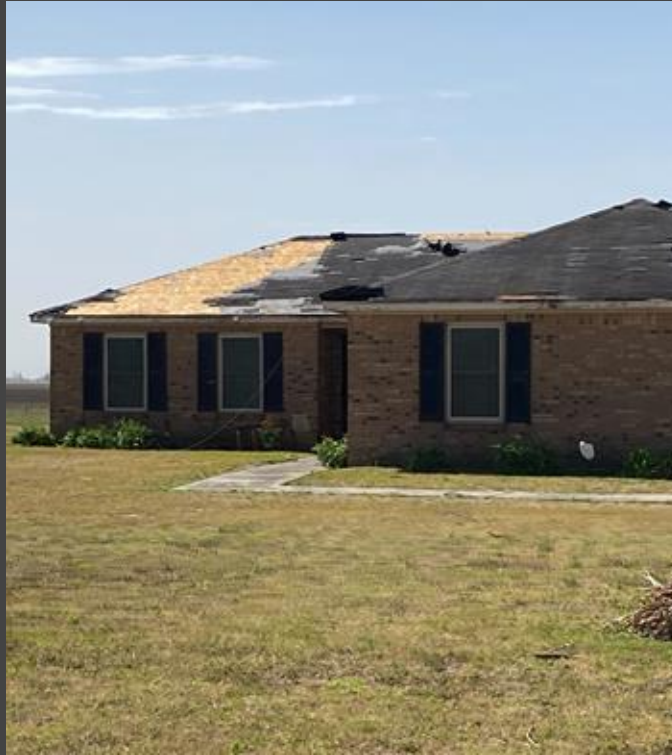
24 Mar 2023 Rolling Fork, MS
DI 2, DOD 4, 97 mph

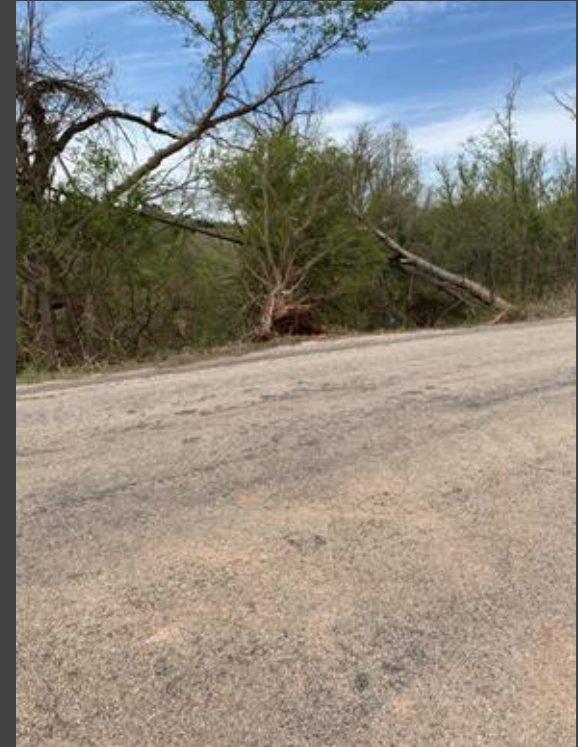
19 Apr 2023 Pink, OK
DI 27, DOD 3, 110 mph

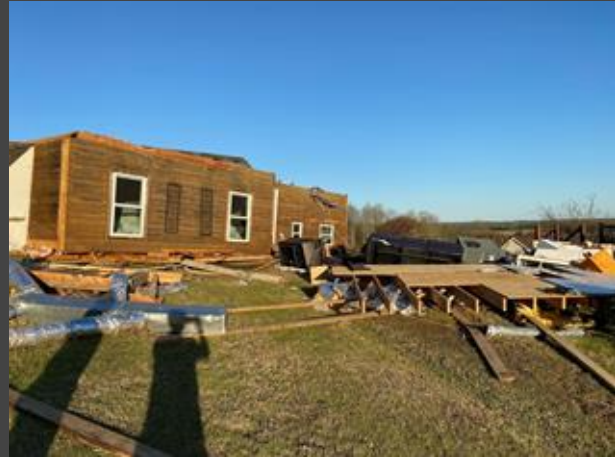
31 Mar 2023 Hookers Bend, TN
DI 2, DOD 5, 121 mph

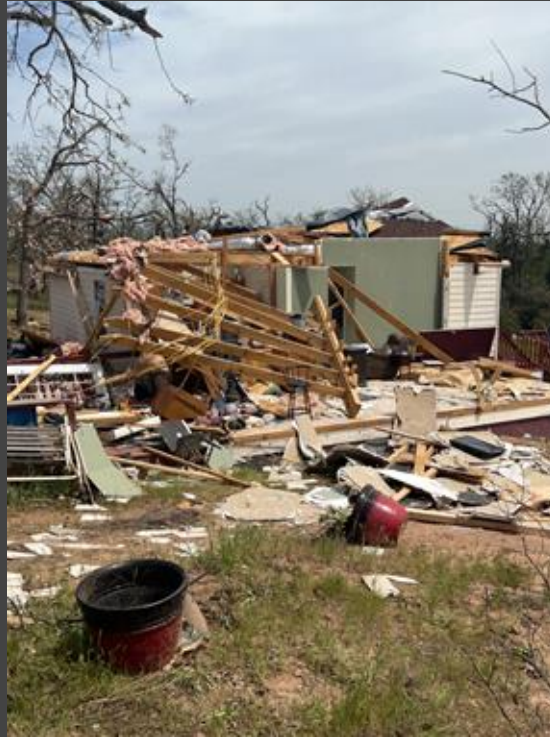
19 Apr 2023 Etowah, OK
DI 2, DOD 7, 132 mph

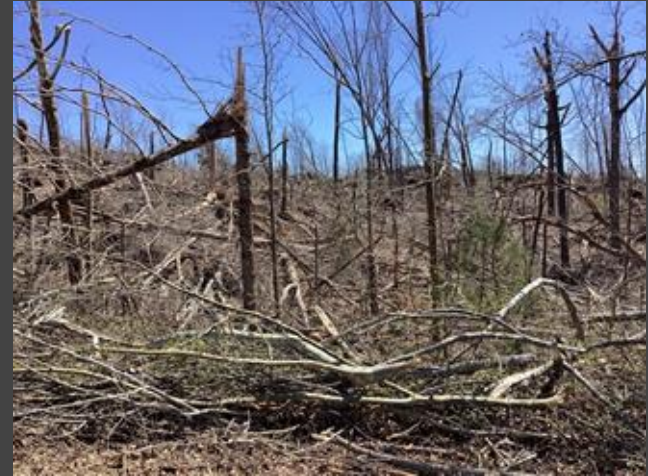
31 Mar 2023 Clifton, TN
DI 27, DOD 4, 120 mph

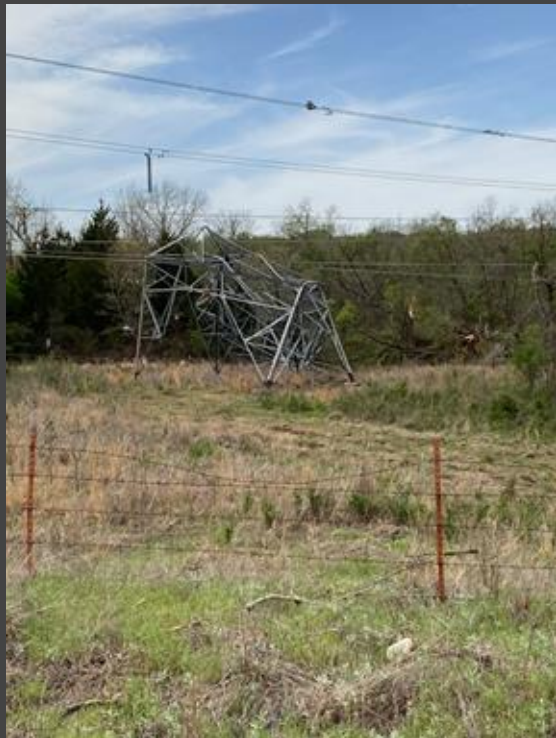
19 Apr 2023 Pink, OK
DI 24, DOD 6, 141 mph

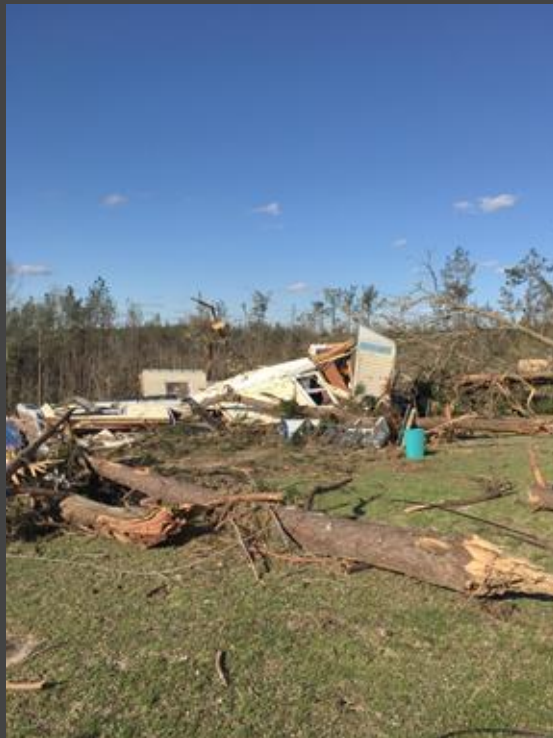
22 Mar 2022 Damascus, MS
DI 2, DOD 9, 145 mph

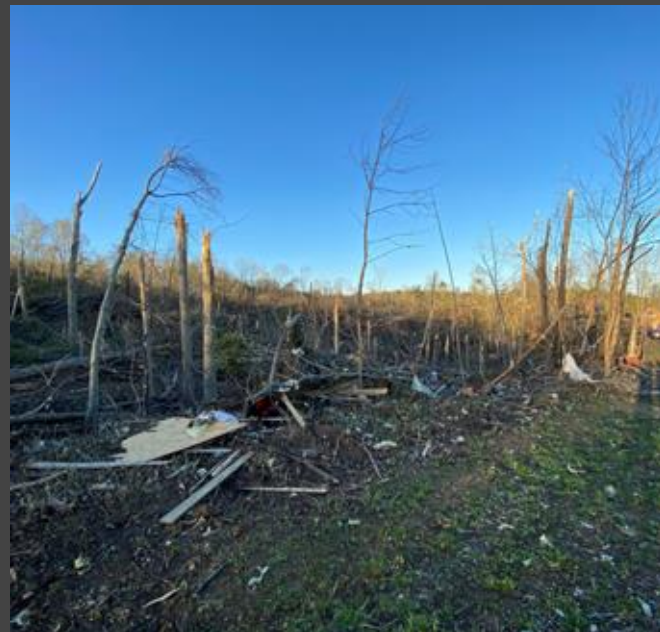
31 Mar 2023 Hookers Bend, TN
DI 27, DOD 5, 145 mph

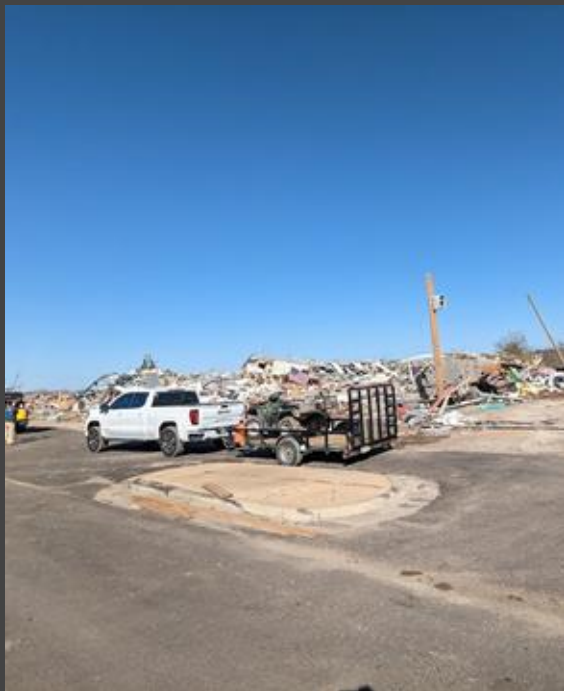
24 Mar 2023 Rolling Fork, MS
DI 21, DOD 8, 175 mph

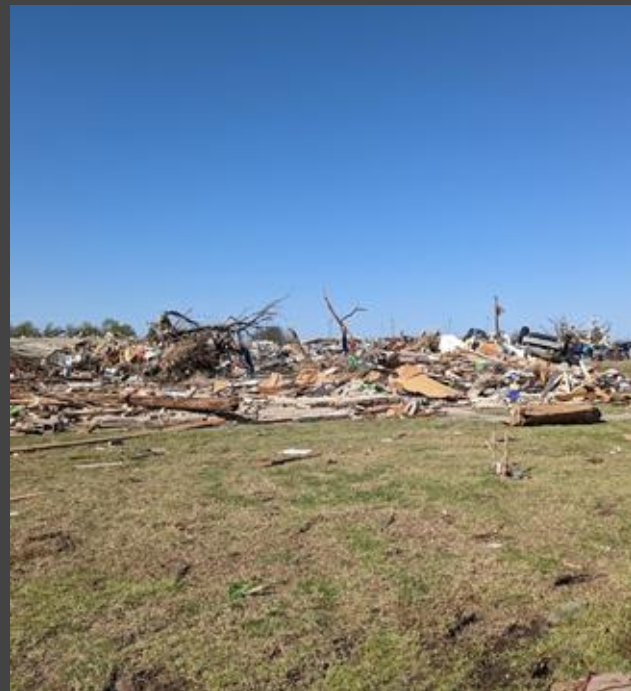
24 Mar 2023 Rolling Fork, MS
DI 2, DOD 9, 190 mph

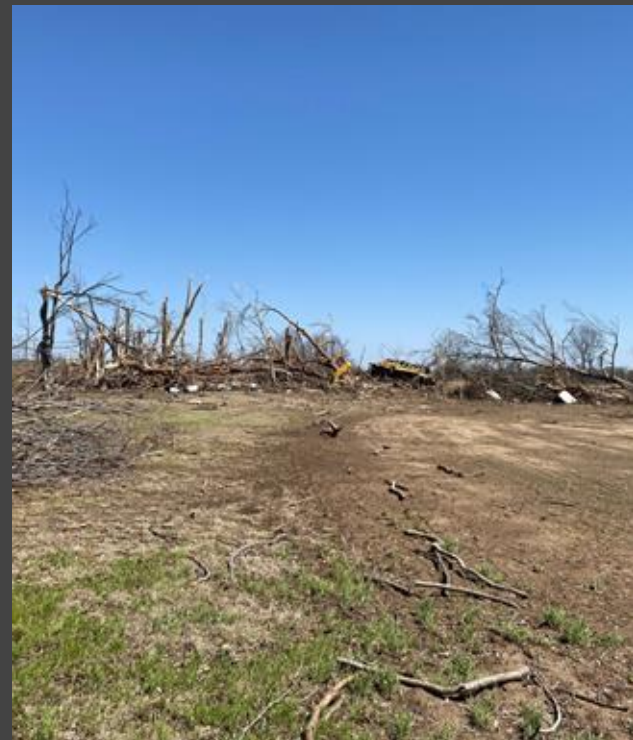
24 Mar 2023 Rolling Fork, MS
DI 27, DOD 5, 167 mph

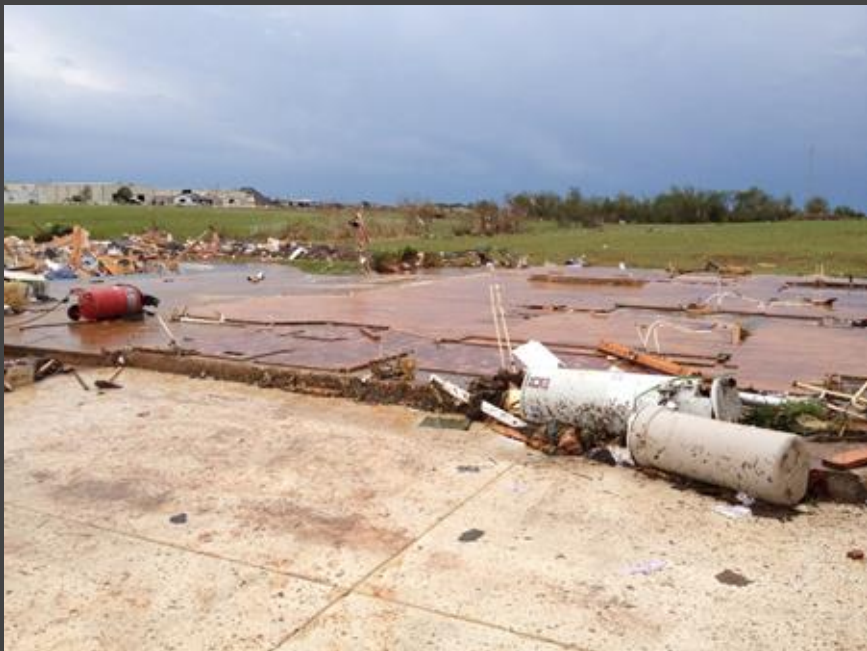
20 May 2013 Moore, OK
DI 2, DOD 10, 201 mph

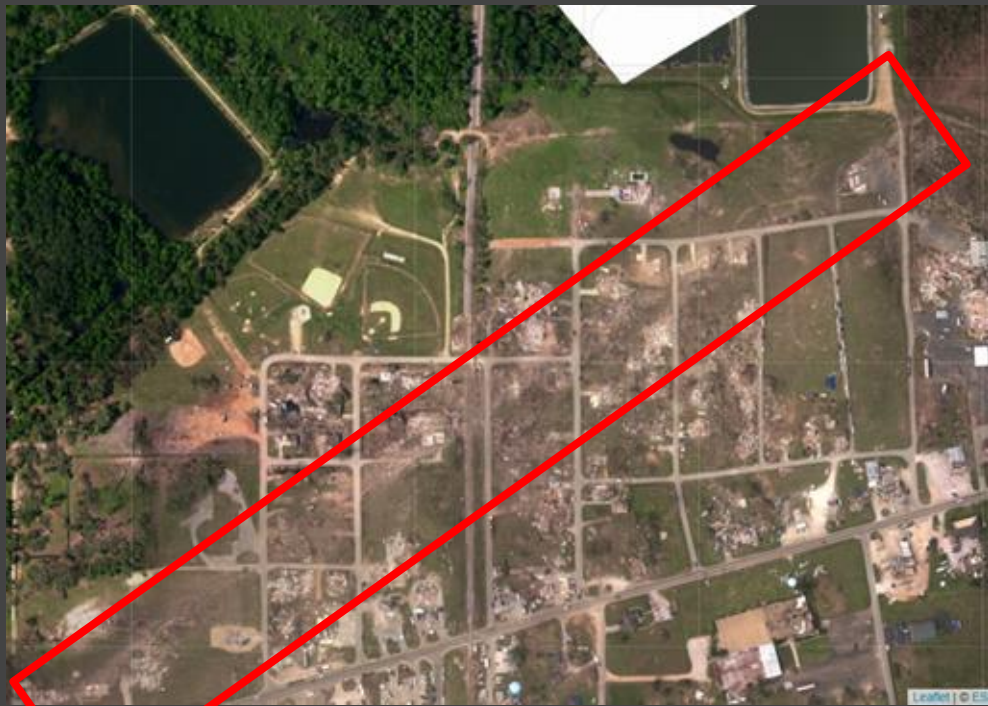
27 Apr 2011 Smithville, MS
DI 2, DOD 10, 205 mph

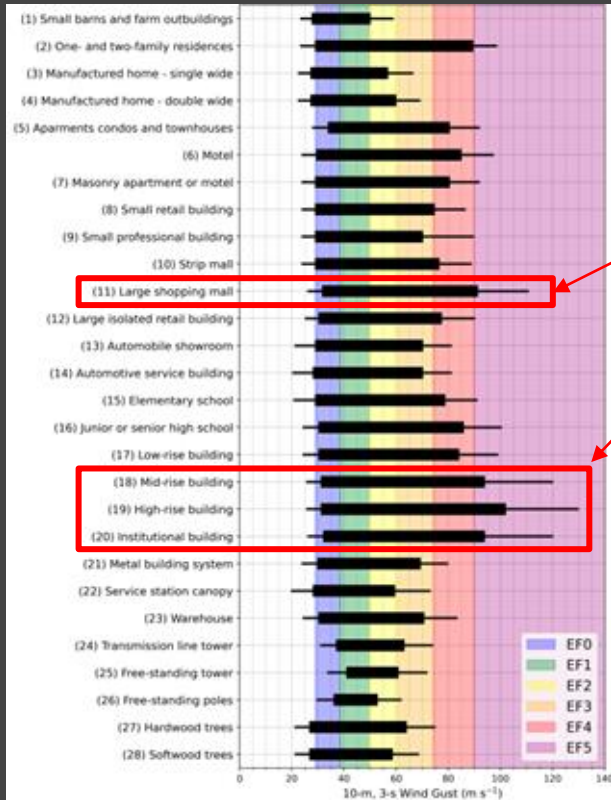
FIG. 1. Graphic highlighting the wind speed ranges for the 28 DIs of the EF scale. The bold black bars represent the range from the expected value of the lowest DOD to the expected value of the highest DOD, and the thin black tails represent the range from the lower bound of the lowest DOD to the upper bound of the higher DOD. The EF-scale wind speed ranges corresponding to each rating are shaded for reference.

- The Ugly: Consistency in EF3–EF5 ratings (continued)
 - Only 4 of the 28 DIs of the EF Scale can yield an EF5 wind speed estimate based on an “expected value” DOD application
 - The end result: only one EF5 tornado since 2014 (20 June 2025, Enderlin, ND)

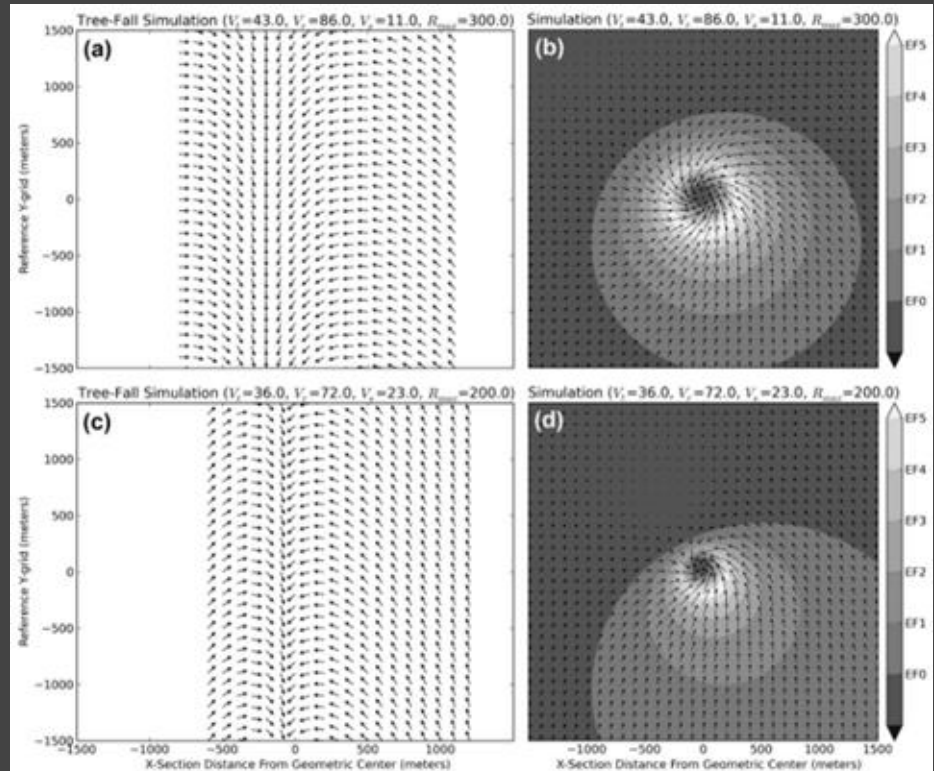
FIG. 9. Best-fit simulations of idealized tornado-induced tree fall and the resulting analytical vortex wind field corresponding to the peak-intensity period for (a),(b) the Joplin tornado (observations shown in Fig. 8b) and the (c),(d) Tuscaloosa-Birmingham tornado (observations shown in Fig. 10b, below).

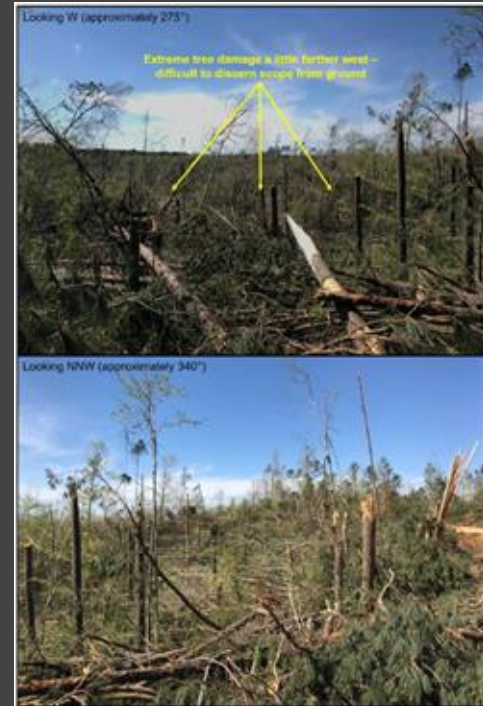
FIG. 3. Images of severe tree damage found by the UAH ground survey team along Brown Taylor Road NNE of the GWX radar. (top) What appeared as likely extreme tree damage just west of the road is noted.

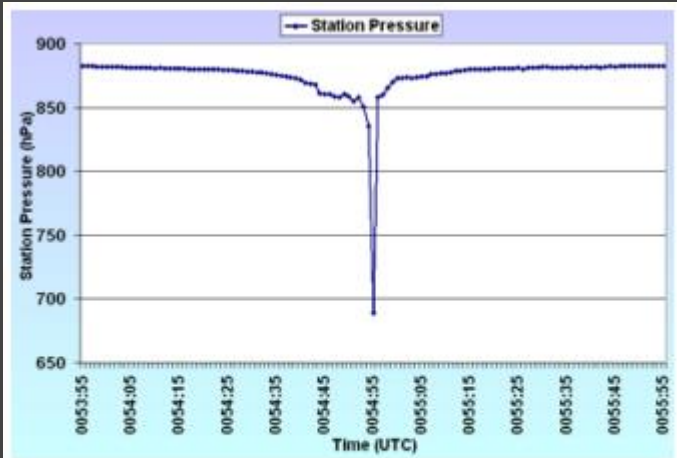
Figure 11: Station pressure (hPa) trace at 2.6 m AGL during a 120 s sample period (0053:55 to 0055:55 UTC). *Click image to enlarge.*

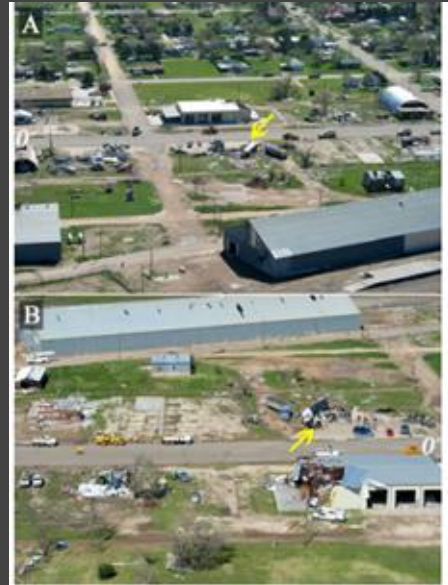
Figure 17: Aerial images of the tornado damage within the industrial region of Tulia. The yellow arrows denote the location of the MM vehicle. View is looking to the east (a), west (b). Highway 87 serves as a north-south reference. Photos by NOAA/NWS Lubbock, Darrin Davis and Zane Price. *Click image to enlarge.*

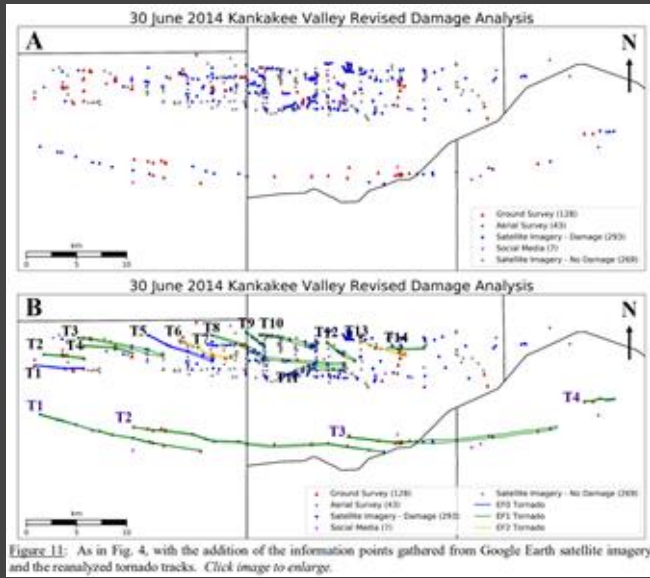
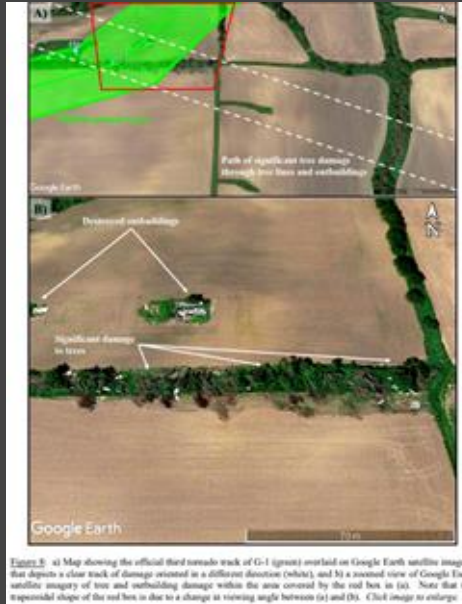
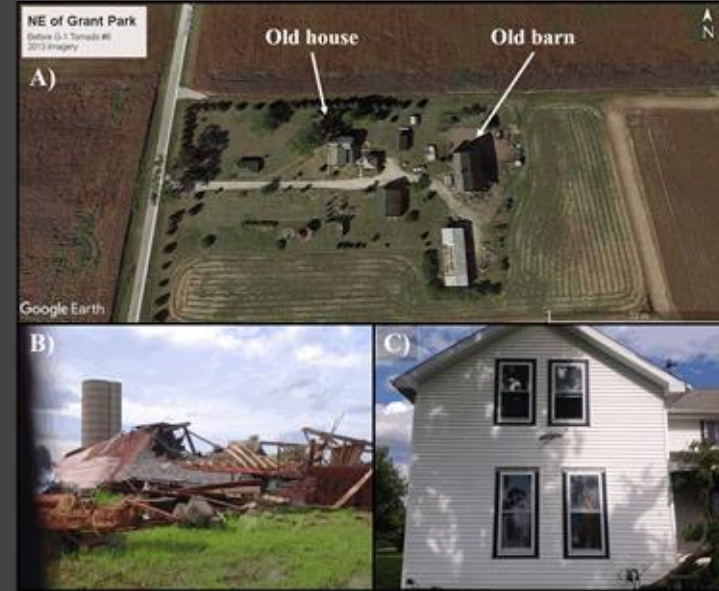
Figs. 11, 8, and A2
 Reanalysis of the Kankakee Valley, IL/IN, QLCS EF0–EF2 tornado
 tracks of 30 June 2014

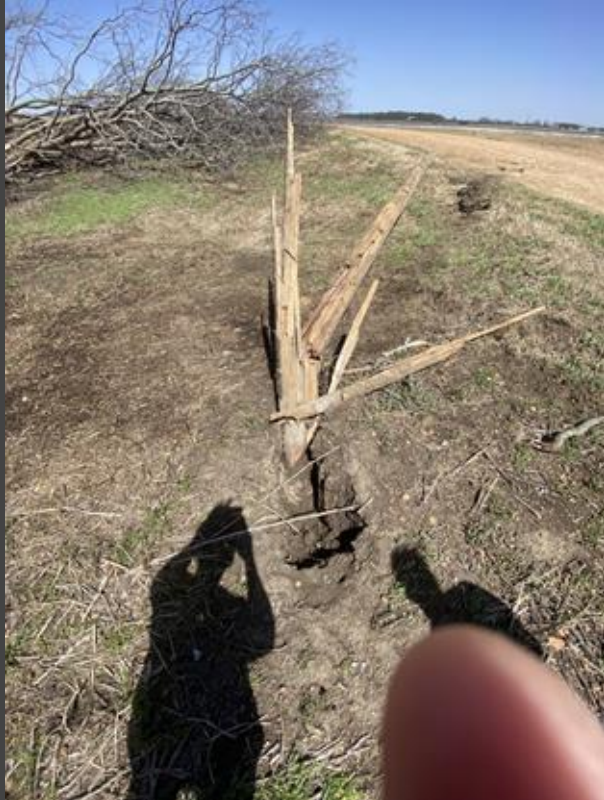
Power pole dragged ~18" through an embankment at Rolling Fork, MS, 24 Mar 2023; rated EF3
